Manhole Inspection Summary

Manhole # S01WW1016MH

Location Address: **6101 PARKINGTON AVE** Cross Street: **BILTMORE AVE**

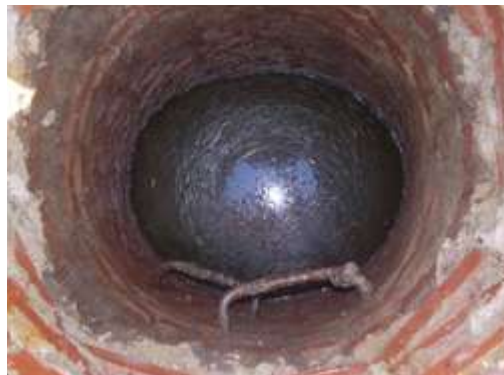
Top View

Comments **Cover Stuck; OPENED BUT MANHOLE IS SURCHARGED 5/7; revisited by jc, ch 6/4/07 revised record to show as CNO
ORIGINAL INSPECTION BY RK&K CREW: CH, IJ 07/28/2006 09:32 AM
COMPLETED BY REI/DRAYCO
LITE CLEANING TO REMOVE DEBRIS FROM CHANNEL**

Surcharge - 1st visit.

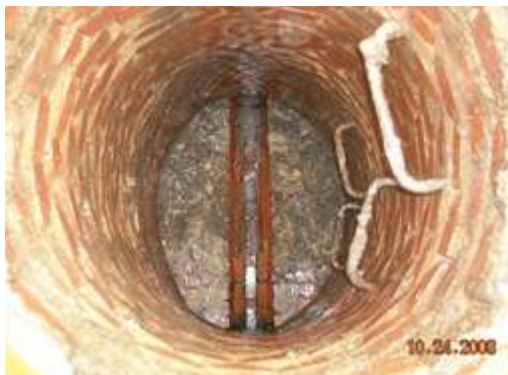
Top View

Bench ☒ Exists Material: **Brick** ☐ Parged ☒ **Debris** (not Condition related)
Condition: ☒ Sound ☐ Cracked ☐ Root Intrusion ☐ Deteriorated ☐ Leaks ☐ Debris

Steps Count: **4** Missing: **0** ☒ **Corroded**

Surcharge ☒ **Evidence Of Surcharge** Depth: **3** (ft.) ☐ Active Surcharge Present

Corroded steps. Evidence of surcharge - Bench debris.

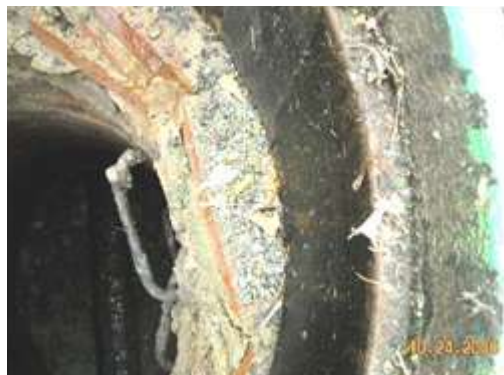
Defect

Frame Offset: **3** (in.) Condition: ☐ Sound ☐ Cracked ☒ **Leaks**

Chimney / Frame Adjustment ☒ Exists Material: **Brick** ☐ Parged Height: **9** (in.)
Condition: ☒ Sound ☐ Cracked ☐ Root Intrusion ☐ Loose Brick ☐ Deteriorated
Infiltration: ☐ None ☒ **Joint** ☐ Cracks ☐ Mortar ☐ Roots ☐ Wall

Frame leaks. Frame offset. Adjustment infiltration.

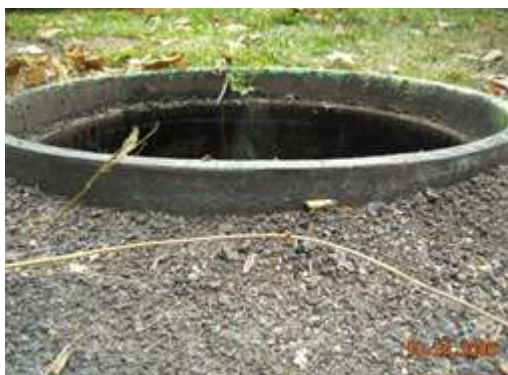
Defect

Above grade.

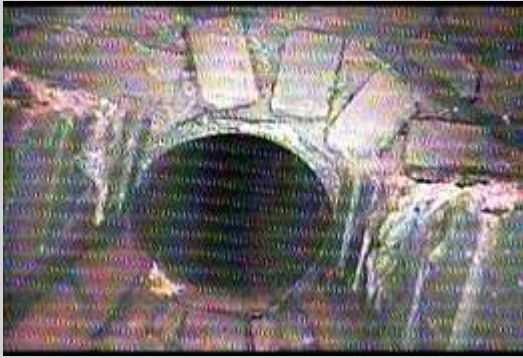
8 in. Circular Gravity Sewer Pipe Out @ 12 O'Clock

Barrel Material: **Brick** ☐ Parged
Shape: **Circular** Diameter: **42** (in.) Length: (in.)
Condition: ☐ Sound ☐ Cracked ☐ Root Intrusion ☐ Loose Brick ☒ **Deteriorated**
Infiltration: ☐ None ☐ Joint ☐ Cracks ☒ **Mortar** ☐ Roots ☒ **Wall**

Barrel deterioration and infiltration.

Infiltration: **Evidence** Pipe Seal Cond: **Cracked**

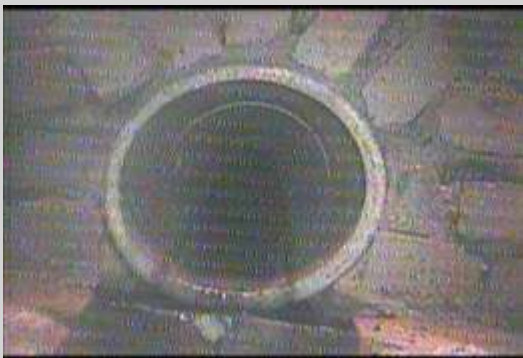
8 in. Circular Gravity Sewer Pipe In @ 6 O'Clock

Infiltration: **None** Pipe Seal Cond: **Broken**
